TECHNICAL NOTE 4019

SOME OBSERVATIONS ON STRESS-CORROSION CRACKING
OF SINGLE CRYSTALS OF AZ61X MAGNESIUM ALLOY

By F. Meller and M. Metzger

Columbia University

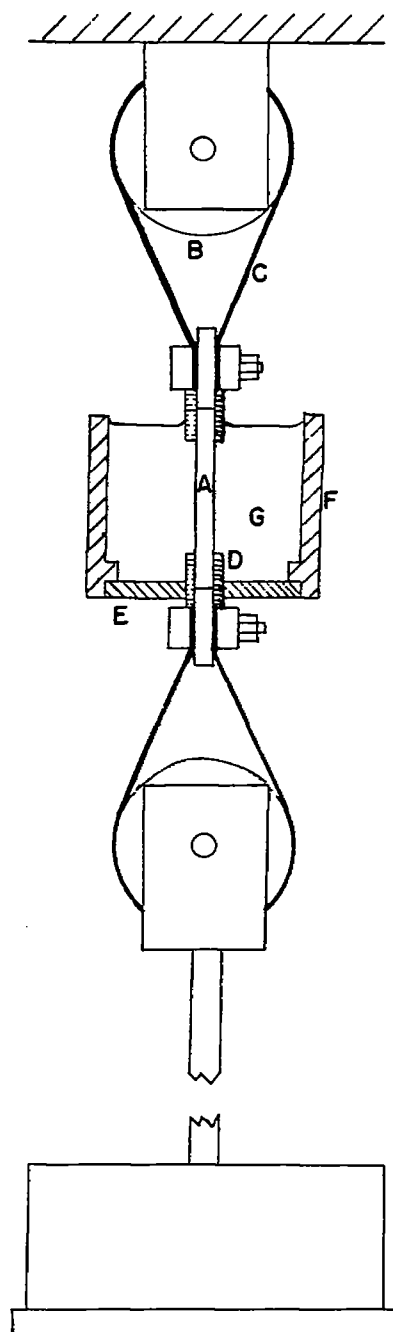
Figure 2.- Side view of stress-corrosion test apparatus. Container for corrodent is shown in section. Letters indicate: A, specimen; B, self-aligning ball bearings; C, steel strips; D, beeswax-rosin masking; E, neoprene plug; F, acrylic cup; and G, corrodent.

The dead-weight loading apparatus for stress-corrosion testing is shown in figure 2. The specimen A is held between steel clamps (later AZ61X clamps) and the load is transmitted by steel strips C looped over self-aligning ball bearings B, an arrangement which enabled fair initial axiality of loading to be achieved (the stresses on opposite edges of the specimen for loads in the elastic range were at worst within 15 percent of each other as determined in several runs on a polycrystalline dummy with the aid of Huggenberger extensometers). Axiality would have been important if failures had occurred under stresses within the elastic range, but no failures were observed until the specimen was well within the plastic range. Axiality cannot then be maintained because of the gross inhomogeneity of the deformation of hexagonal single crystals, especially under the present conditions, where (1) the ratio of test length to specimen width is low so that bend gliding at the ends of the test length can influence a substantial portion of the test length and (2) a grain outside the test length may be so much more favorably oriented for slip that it is the first to slip, thus making axial loading of the grain under test impossible. For these reasons, many of the failures observed may have been initiated by local stresses much higher than the nominal stress.

The corrosive G (fig. 2) was held in an acrylic cup F fitted with a neoprene plug E which slid over the beeswax-rosin masking D at the ends of the specimen, this joint and the steel clamps being covered with petrolatum for added protection. Wax masking was also applied at the upper end of the specimen so that the specimen was not exposed at the air interface. The cup was covered during the test to minimize evaporation but to permit access of oxygen. At the start of each test, the corrosive was always added before applying the load. The specimen had previously been electropolished in the polishing bath of hydrochloric acid and Cellosolve in order to facilitate the observation of cracks and strain markings during the test.
